**AT&T CORPORATION'S
EXPERT WITNESS
DISCLOSURE**

**Investigation of Fiber Optic Cable Damage
AT&T Bozeman, MT to Three Forks, MT Route
August 1, 2013**

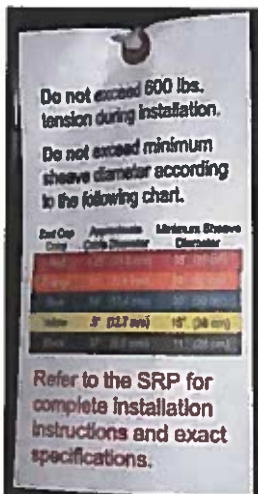
Figure 1: End cap color guidelines.

Make sure the cable has a good traverse, free of crossovers, loops or excessive slack. Verify the print statement is correct and legible. In some cases, bulk reels are direct-shipped with a colored vinyl cap on the end of the cable to provide guidance for tensile capability and minimum bend diameter. (See Figure 1.)

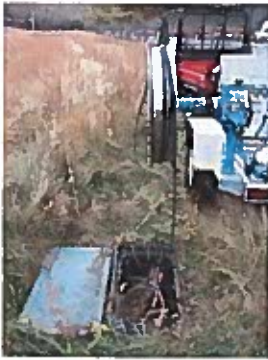
Figure 5: Midspan cable take-up with take-up equipment appropriately placed in line with the duct.

When the cable exits the subduct, whether below grade or from the pedestal, it is imperative that the cable not rub against the wall of the subduct at an angle under tension, as this will affect the cable structure. This can occur when the amount of subduct length is too short, and the duct cannot provide the proper cable bend radius control. (See Figure 4.) Whenever possible, it is best to position the pulling equipment in line with the duct. (See Figure 5.)

Acceptable Methods (Figures 5 - 7)
